## Why did SWMO choose this Project?

# SCOTT WATERSHED MANAGEMENT ORGANIZATION (SWMO)

# WATER QUALITY PROJECT FACT SHEET QUARRY CREEK RAVINE STABILIZATION

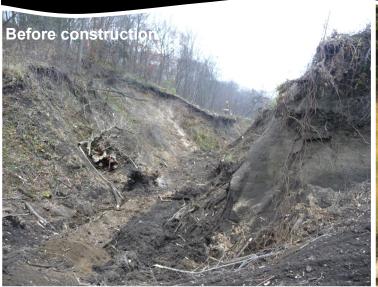
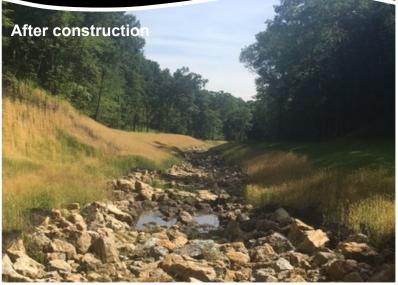
**Above:** Before and after photos of the same location in the ravine **Below:** Construction photos of the sheet pile structure and ravine

- 2,600+ linear feet of riprap channel stabilization
- 750+ linear feet of turf reinforced matting channel stabilization
- 29 rock check dams
- 2.0 acres of in-ravine water detention
- 1 grade stabilization
- 2,000+ linear feet of grassed waterway
- 300 linear feet diversions
